EROSION IN ROCKET MOTOR NOZZLES

M. E. DE MORTON

Materials Research Laboratories, Maribyrnong, Victoria (Australia)

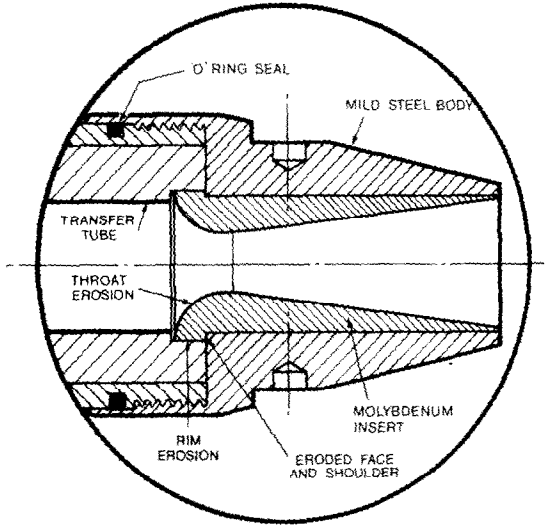
Fig. 1. Details of the Mo insert in the nozzle assembly and the position of the various forms of erosion.

The types of erosion observed in the three nozzle assemblies examined were similar and occurred in three separate sites, as illustrated in Fig. 1. Firstly, severe local erosion occurred at the throat section of the Mo insert and is shown in Fig. 2. Secondly, erosion tracks were present at the outer rim of the Mo inserts (Fig. 3) and thirdly excessive erosion was observed in both the insert and steel body at the restraining shoulder of the insert (Figs. 4 and 5). This erosion had allowed movement of the inserts relative to the body and in the direction of the gas stream of up to 6 mm.

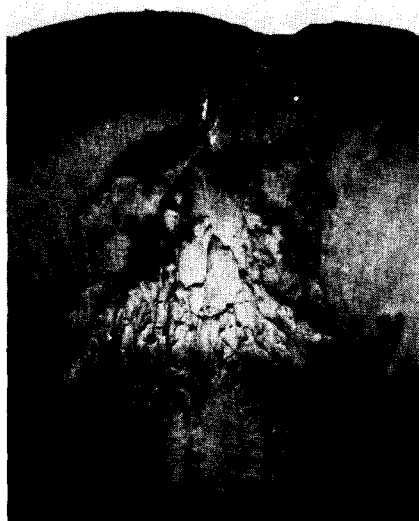
Fig. 2. Severe erosion at the throat and outer rim of the Mo insert (top). (Magnification 3.3 \times .)

rim of the insert (Fig. 3) and the localized erosion in the throat, as shown for example in Fig. 2. Melted material had also flowed into the gap between the insert and body during firing, as shown in Fig. 3. Talysurf measurements of these droplets gave a thickness of 0.12 mm.

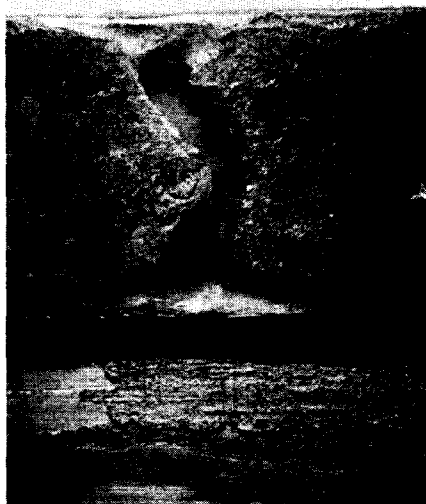
Fig. 3. Liquid metal erosion at the shoulder and outer rim of the Mo insert. Note the metal wash, present as a thin layer below the shoulder. (Magnification 6.6 \times .)

Microscope examination of the droplets indicated a two-phase eutectic-type structure and electron probe microanalysis (EPMA) showed that the droplets contained 12 - 40 wt.% Mo. Subsequent analysis showed carbon also to be present. The ternary C-Fe-Mo equilibrium diagram [4] indicates that an Fe-Mo-C eutectic occurs in the composition range 2 - 20% Mo and 4.2% C. This eutectic has a melting point of about 1370 K, *i.e.* less than half the melting point of Mo and well below measured gas flame temperatures.

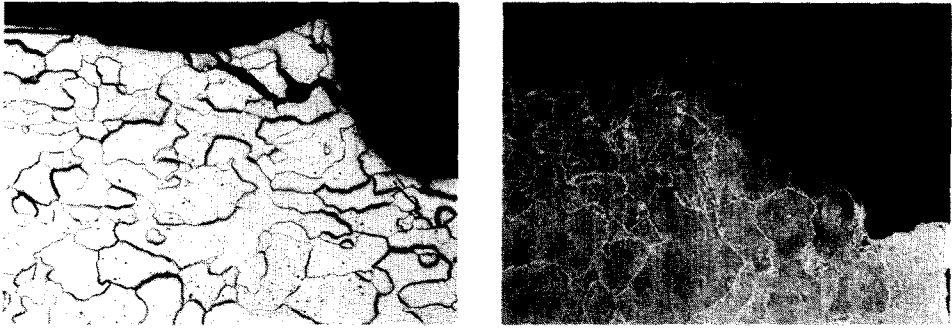
Fig. 4. Section through the Mo insert shoulder showing cracking caused by excessive loading. Dissolution of Mo to form an Fe-Mo-C eutectic layer is shown at the top left of the figure. (Magnification 27.5 \times .)

Fig. 5. Restraining shoulder of the mild steel body showing complete erosion of the corner, carbon pickup at the surface and a residual eutectic layer at the final seating. (Magnification 27.5 \times .)

Examination of metallographically prepared sections from the throat of the Mo insert showed that an adherent eutectic layer had formed at the shoulder region which had completely wetted the surface of the Mo; cracking had also occurred in this region (Fig. 4). These features allowed the insert to move along the steel body in the direction of the gas stream. Detailed examination of the surface layer showed that, as the thickness of the eutectic layer increased from the outer rim of the insert to the hotter throat area, the adherence of the layer to the Mo surface became poorer. This is shown progressively in Fig. 6(a), (b) and (c). Furthermore where excessive breakaway of the surface layer occurred there was evidence of diminishing grain boundary cohesion in the insert and removal of whole grains of Mo from the surface was observed (Fig. 6(c)). Additional EPMA work on the insert surface layers (Fig. 7(a)) showed that they contained basically Mo

Examination of the etched radial section of the steel body near the restraining shoulder (Fig. 5) showed that the hot reducing gases had penetrated along the interface between the transfer tube and the insert and carburized the surface layer to a depth of 0.2 - 0.3 mm causing substantial grain growth in this area. This surface of the body was badly eroded and almost entirely eutectoid (about 0.8% carbon) in the form of fine pearlite. Furthermore, material at the shoulder of the steel body had been removed to form a circumferential groove beneath the insert shoulder. The formation of this groove and the eroded top surface during firing suggests an explanation for the origin of the low melting eutectic. This explanation is based on the assumption that the carbon char, accelerated down the transfer tube at velocities near to the gas velocities, would remove material on impact with the heated steel surface at the shoulder region. This process would be similar to the mechanical erosion observed in coal-fired boilers, caused by the impact of high velocity abrasive ash particles on mild steel heater tubes [5], where it is found that the metal loss is proportional to the impact velocity of the ash and is a maximum at oblique impact angles. Particles removed from the surface of the steel body in this manner* would quickly melt at the gas

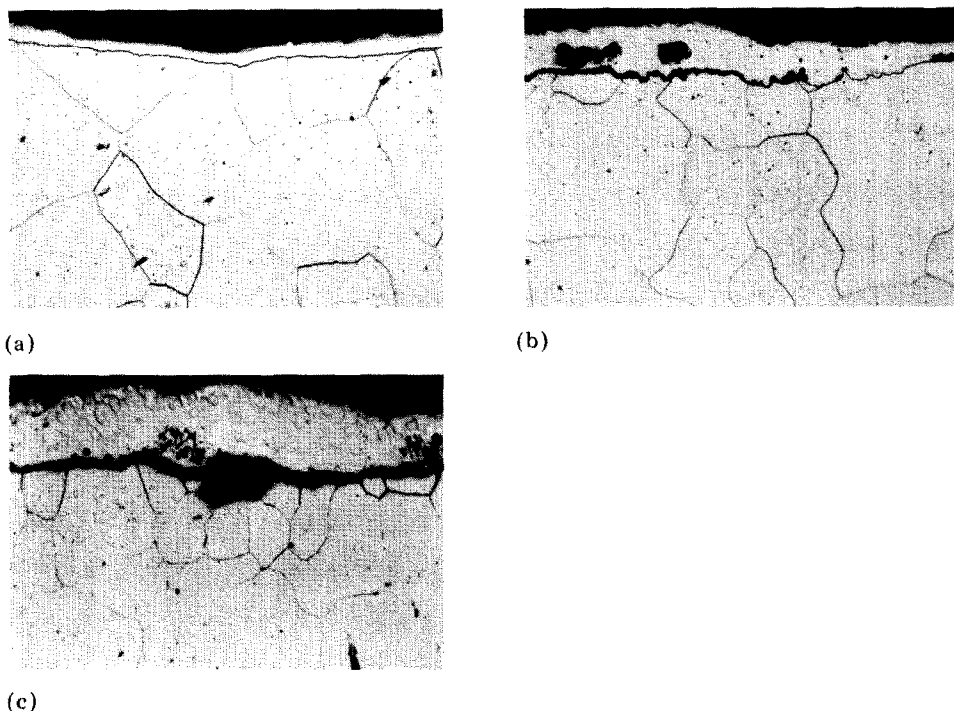
Fig. 6. Sections through a Mo insert showing an increasing thickness of both the eutectic layer and the subsurface oxide: (a) on the outer rim, (b) near the throat and (c) in the region of severe throat erosion. Note the grain boundary oxidation and the absence of grains in (c). (Magnification 275 \times .)

(Fig. 7(b)) and Fe (Fig. 7(c)) with carbon distributed fairly uniformly throughout (Fig. 7(d)). Oxygen, however, was localized in the subsurface layer (Fig. 7(c)). In the region of the insert throat where excessive erosion had occurred a dark phase was present along grain boundaries (Fig. 6(c)). An EPMA scan for oxygen across the dark phase showed a high concentration, as indicated in Fig. 8. In some areas oxygen had infiltrated to a depth of five to ten grain diameters.

The existence of oxygen at the grain boundaries in the eroded regions in the insert throat is a more problematical issue because of the reducing nature of the burnt gases. A possible explanation for this intergranular oxidation, however, is that small amounts of oxygen would be available for exchange in the localized non-equilibrium regions from oxides transported with unburnt char in the combustion gases and this would form a subsurface oxide. Diffusion of oxygen from this subsurface oxide layer to and along grain boundaries would occur more rapidly in the higher temperature throat region (Fig. 6(c)). After grain boundary embrittlement, removal of the grains from the surface by the forces associated with the high velocity gas stream would follow as a consequence.

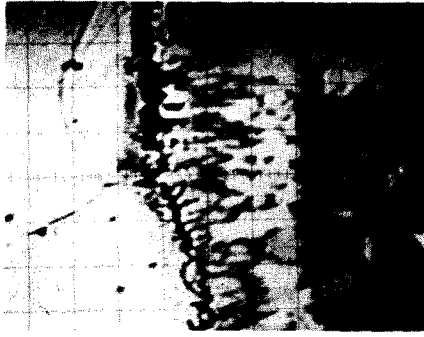
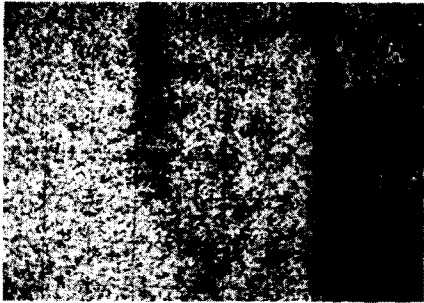
Fig. 7. Electron probe microanalysis results on the Mo insert and surface layers showing the distribution of Mo, Fe, C and O. (a) Area scan, (b) Mo X-rays, (c) Fe X-rays, (d) C X-rays, (e) O X-rays. (Magnification 825 \times .)

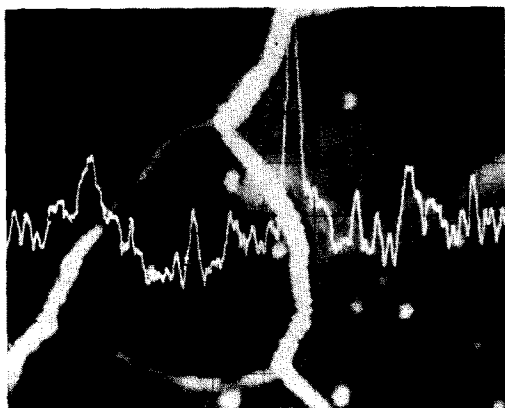
Fig. 8. Electron microprobe scan showing the concentration of oxygen in the dark phase present at grain boundaries near the insert throat. (Magnification 1500 \times .)
