The Hindenburg tragedy revisited: the fatal flaw found

Addison Bain^a, Wm. D. Van Vorst^{b,*}

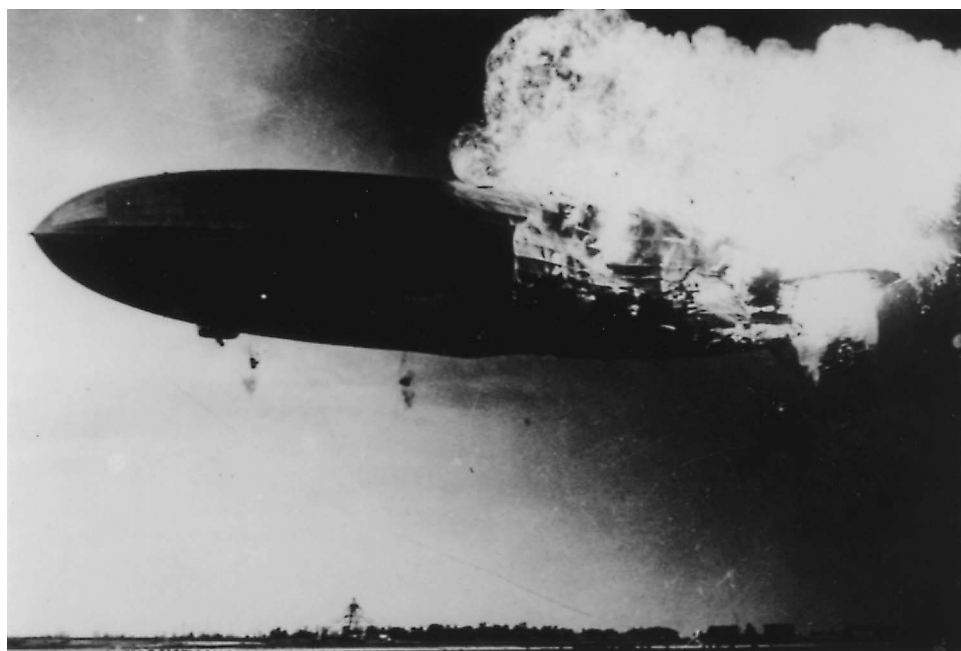
Fig. 2. The Hindenburg, 6 May, 1937.

Figure 2 shows the beginning of the disaster of 6 May, 1937, in which 35 of the 97 persons aboard perished. It is worthy of more than a passing glance, especially in view of the conclusions reached by the Board of Inquiry in seeking an explanation of it. There were two such Boards, in fact, and each concluded that some hydrogen had, in a manner never explained, become free, was ignited electrostatically and exploded. Figure 2 is a photograph made from a 'newsreel' film being made of the landing, and defines the first fraction of a second of the ignition. In studying the frames of the newsreel following that reproduced as Fig. 2, it can be inferred that one or two of the hydrogen gas cells in the rear, severely overheated and consequently overpressurized, burst providing a 'jet effect' from the escaping (and then burning) hydrogen which gave a forward thrust to the airship—still in trim. This sudden motion dislodged two waste water tanks (which, in the newsreel, can clearly be seen to be in free fall). This loss of ballast in the front end of the ship caused the nose to rise. Thus the fire moved forward, making survival even more difficult. It would take undue space to reproduce the several frames in the newsreel as figures here, but study of Fig. 2 itself

raises issues. Clearly, there was no instantaneous explosion, and the ship is still in trim. What was burning? Hydrogen burns with a colorless flame, while witnesses compared the flames with a fireworks display. And, the

picture indicates some downward burning. Hydrogen would typically burn only upward!

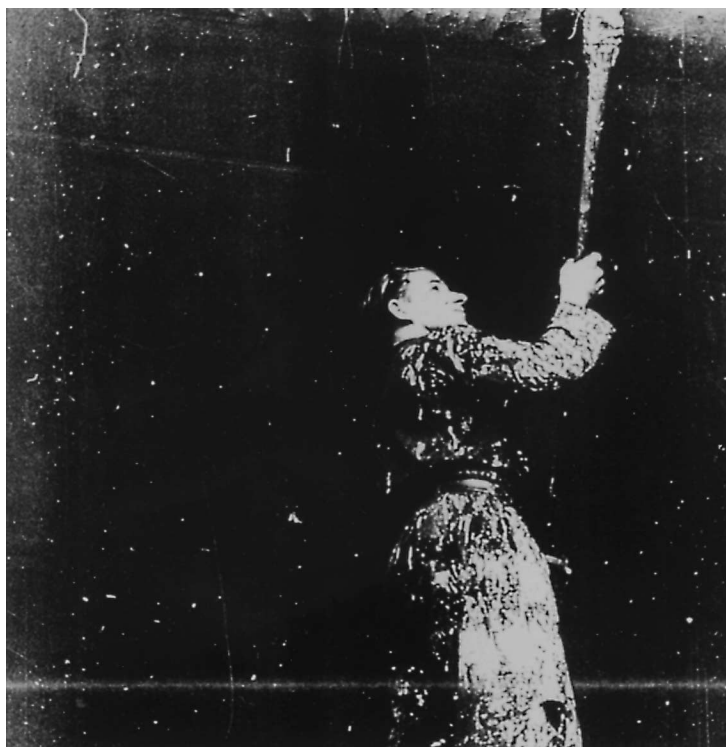
Fig. 3. Application of the ‘Doping’ compound.

special (for an American) privilege extended by the Zeppelin company. The Zeppelin works, and the museum were also visited. The statements and discussion that follows are based on the information obtained from these sources. In particular, this information, and the laboratory tests implied, allow an authoritative description of the fabric. The covering itself was made of a cotton fabric. In order to tauten and weatherproof the fabric a ‘doping’ was applied—in a rather primitive manner, as shown in Fig. 3. The procedure made for an uneven application, to say the least. And the choice of the doping materials does defy (today’s) logic. The first coat was an iron oxide and was followed by four coats of a cellulose butyrate acetate, which included a suspension of aluminum powder. The total mix might well serve as a respectable rocket propellant. Figure 4 is also worthy of note. It shows the manner of securing the cotton fabric covering to the Hindenburg’s structural frame. The cord used to draw the two edges of the fabric together was made of ramie, a very strong textile made from a nettle native to China. The opening had to be covered, of course, and this was accomplished by the use of wooden dowel spacers and faring strips over which a strip of the covering fabric was held in place with the cellulose acetate doping compound. This made the covering highly non-conductive. There must have been about 100 such closures dis-

tributed around the surface of the Hindenburg. As a result of the electrostatic activity, the skin became highly charged, and finally passed the current through the skin to the frame. In the process, the skin and its highly energetic doping constituents were ignited, setting off the conflagration. The fire quickly engulfed the wood doweeling and fairing, the doped fabric, and other fabrics—even silk in the passenger staterooms. It became a raging inferno in seconds, and, according to information from the Fire Sciences Laboratory, would be classed (from the colorized photograph) as a cellulose fire, not unlike a forest fire.
